Emergency Watershed Protection Program (EWPP) Maui, Hawaii – Kula Fire:

Overview

Kula Fire DSR Map

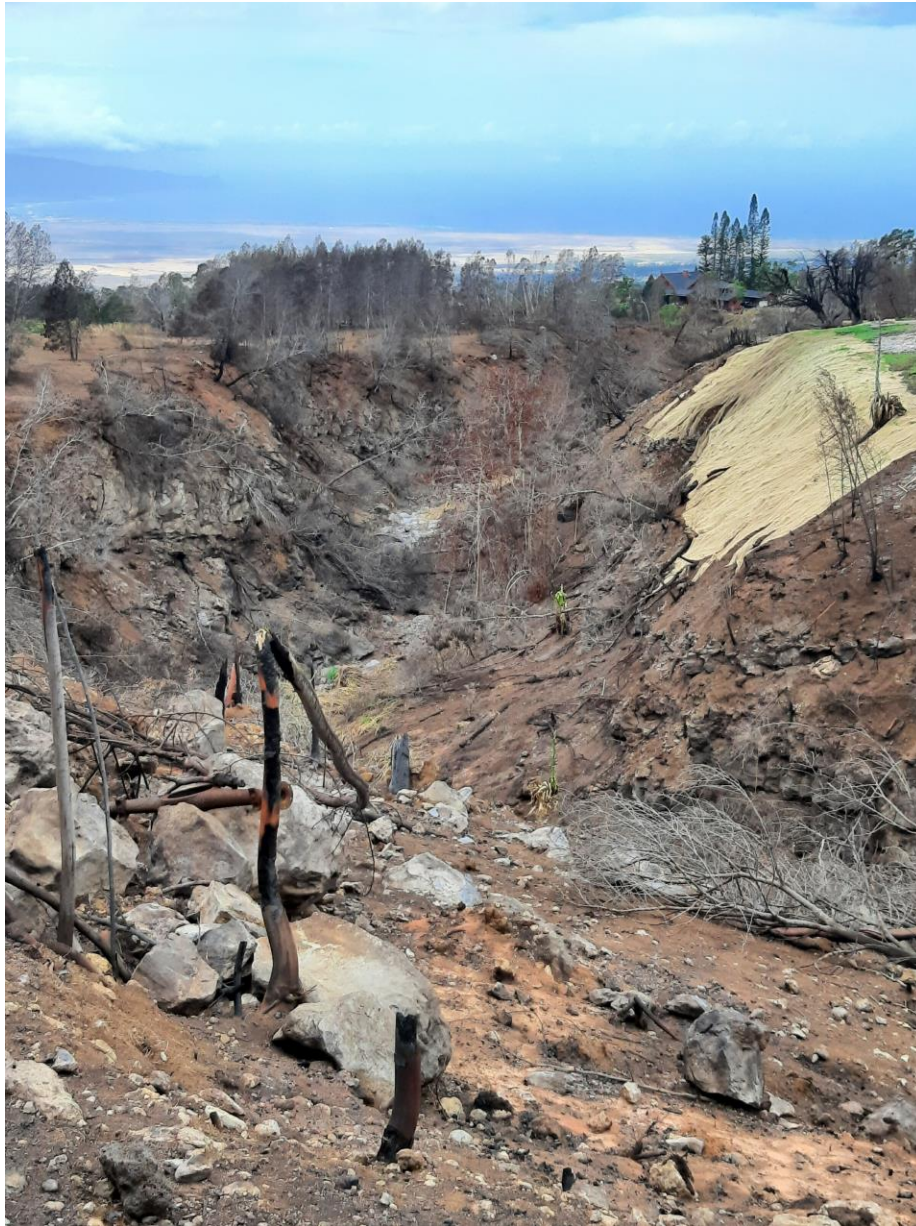
highest along the outer banks of the gulch where fuel loads were high, wind was unobstructed, moisture was low, and convective heat was transferred from lower in the gulch.

Pulehu Gulch looking downstream

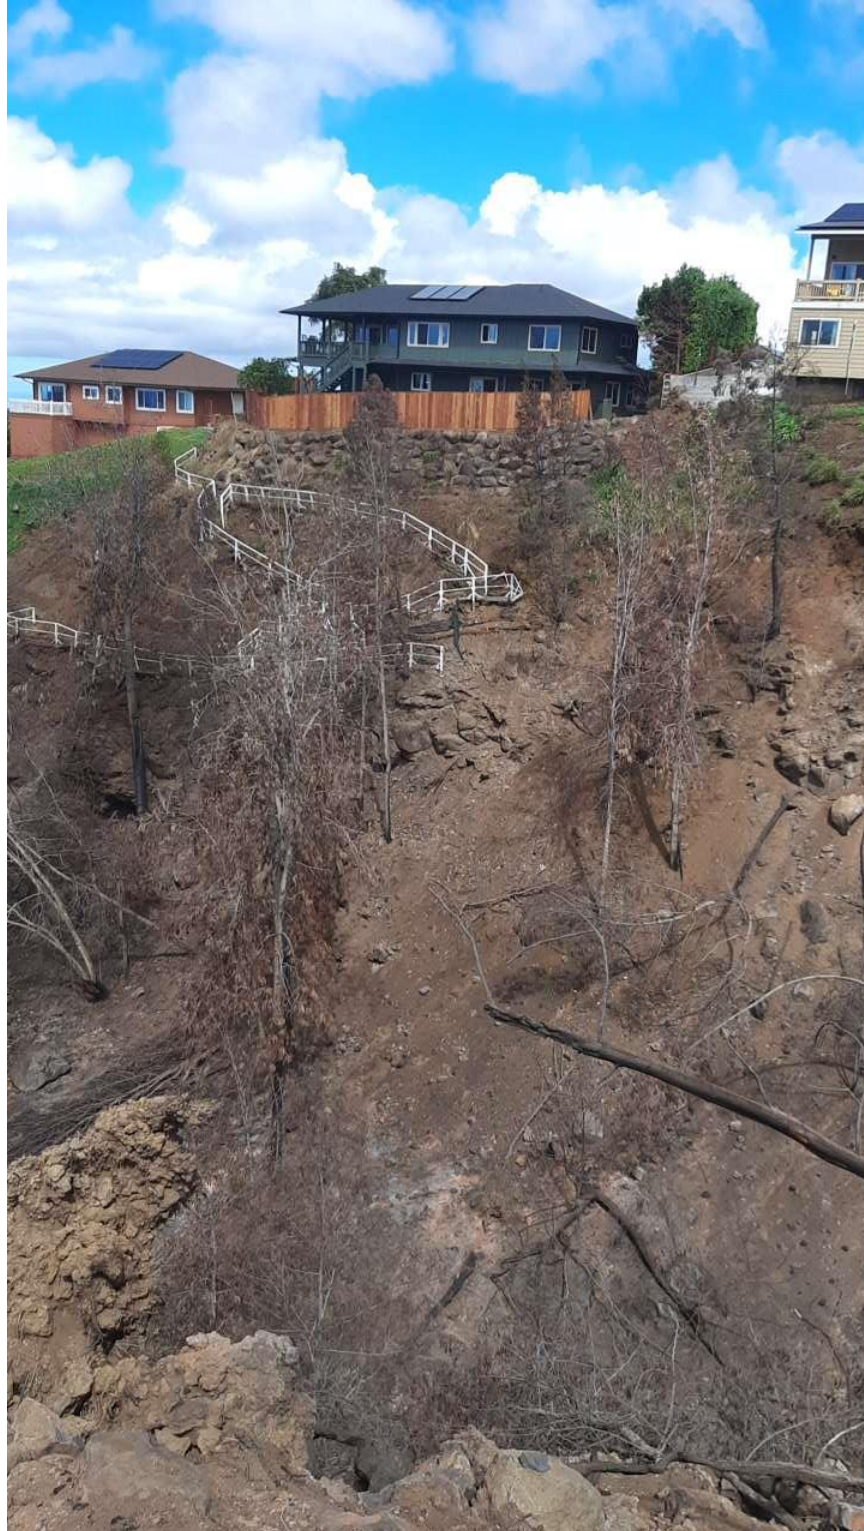
Erosion and woody residue below house foundations along Pulehu gulch.

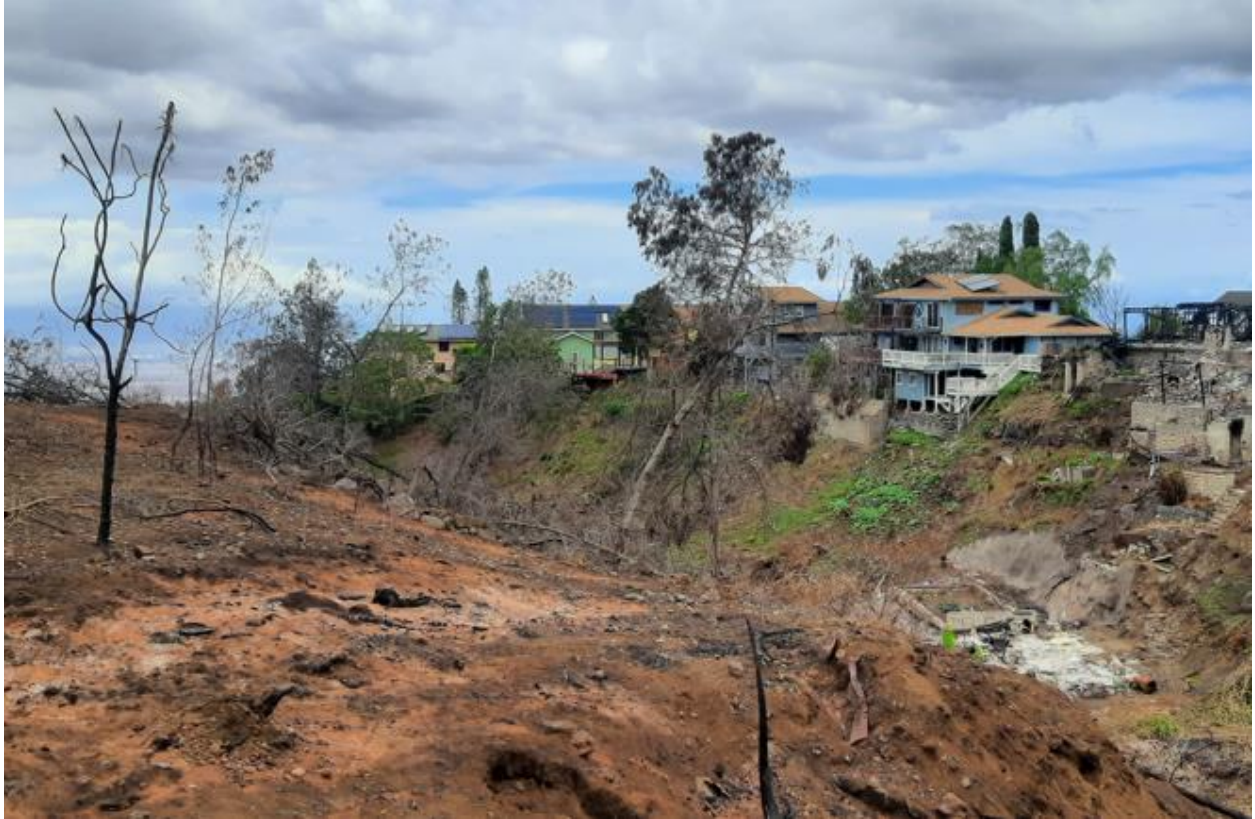
Several of about 25 houses at risk of foundation erosion along Pulehu gulch

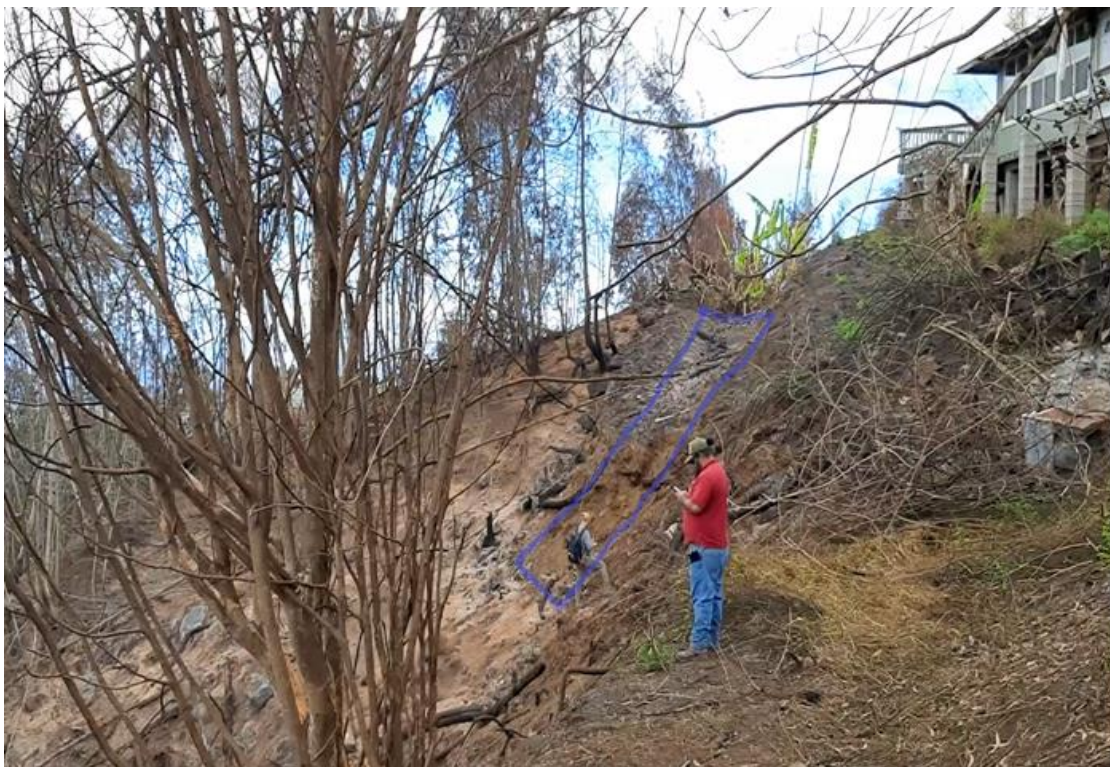
Site of proposed gabion mattress to control erosion (blue outline)

NRCS recommends use of a 48 x 12 x 1 foot gabion mattress below the house at 20.77571 N, 156.30572 W. This house is located at the top of a steep hill with a gully forming below it. The gully has been destabilized by the loss of vegetation and the house appears to be built on backfill material that is less stable than the surrounding soil. The proposed gabion will convey water over the unstable backfill material and discharge it onto a competent rock shelf. Adjacent to this property is a rock retaining wall that has also been destabilized by the fire. NRCS recommends a vegetative buffer using vetiver grass (*Chrysopogon Zizanioides*) plugs to help stabilize this wall and prevent rocks from sliding into a house.

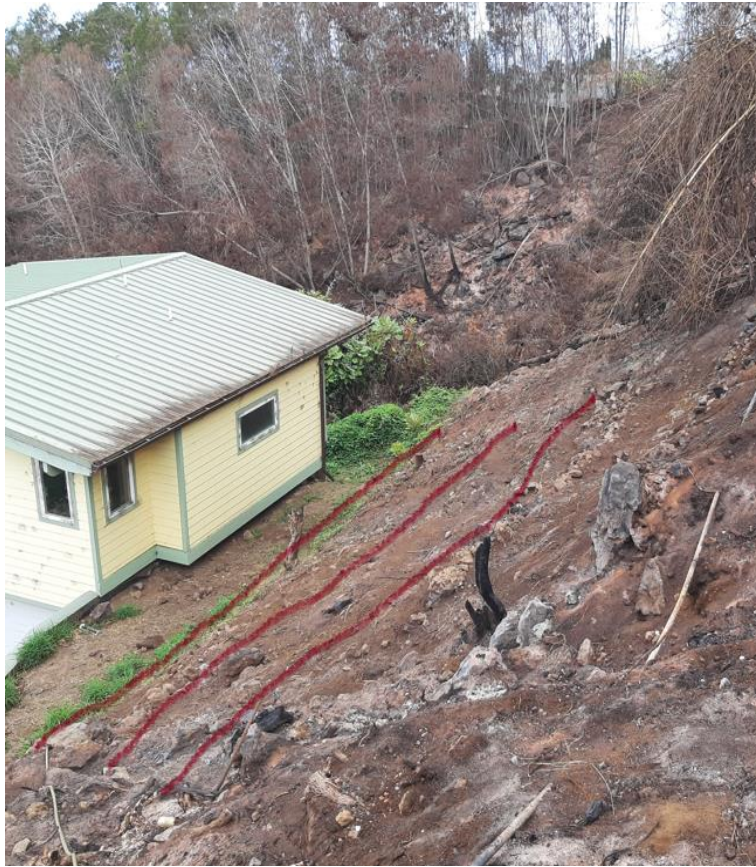
Site of proposed vegetative buffer (brown lines)

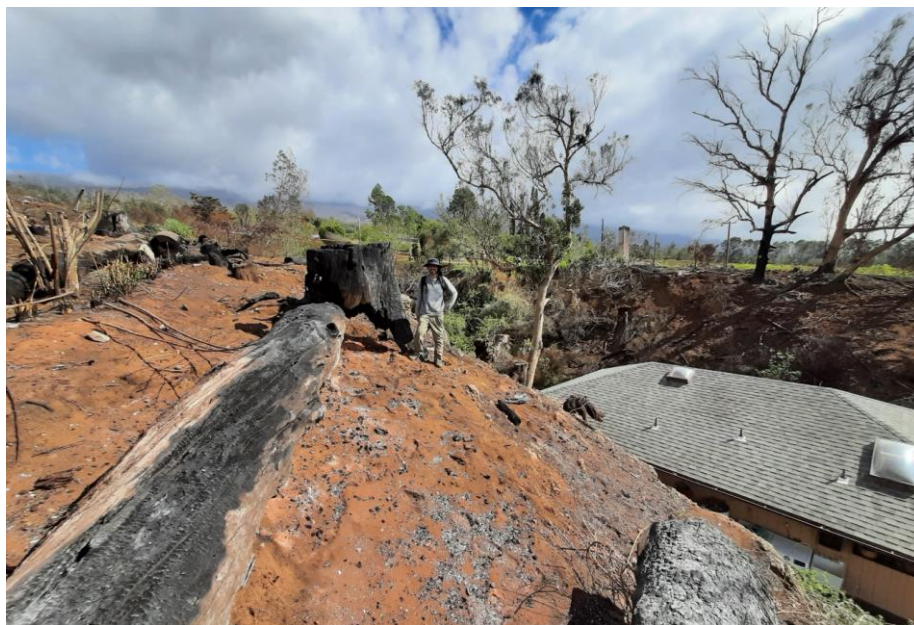
Site of proposed clearing and mulching to protect house in gulch

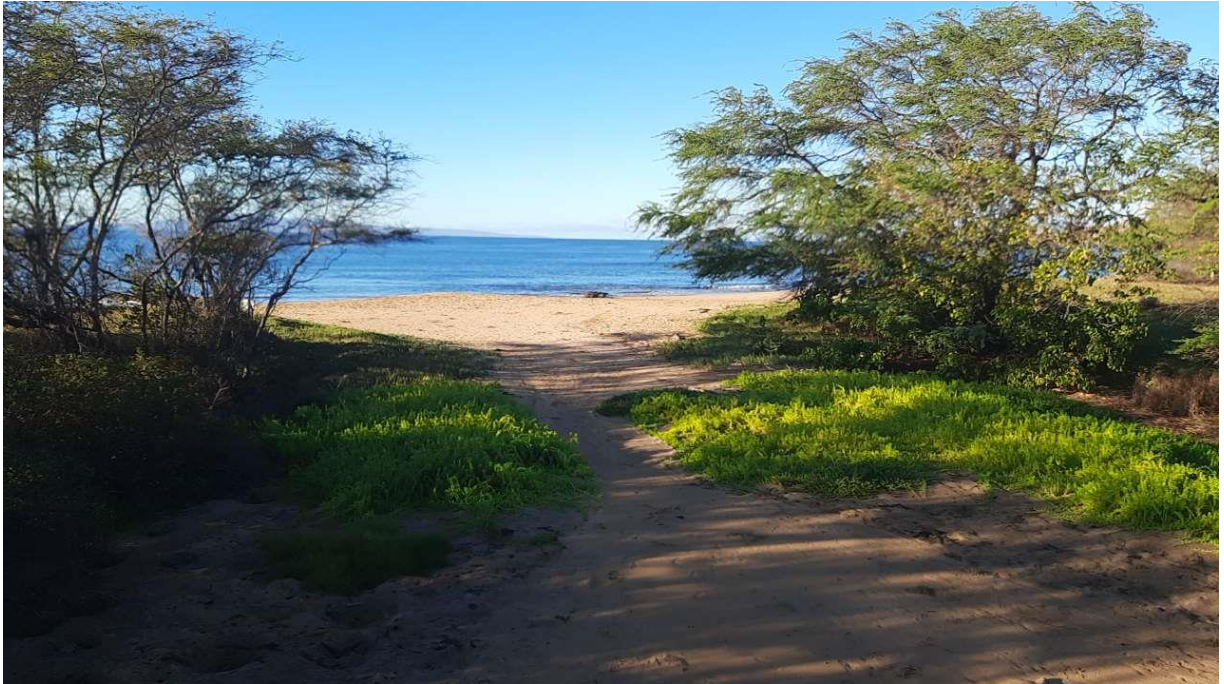
Outlet of the Pulehu gulch watershed into Maalaea bay

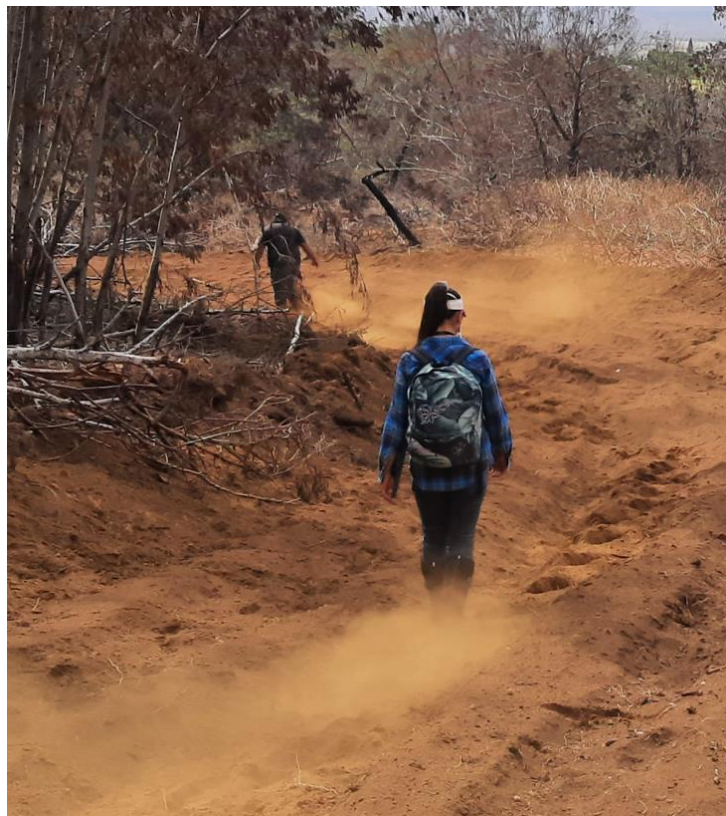
Wind erosion is another resource concern. The soil's high silt and ash content is prone to wind erosion.

Airborne silt from foot traffic above the Kula firebreak

NRCS recommends converting the firebreak along the SW bank of Pulehu Gulch, below Route 377, into a gravel access road. A gravel road will provide equipment access to the SW bank of the gulch, reduce dust, reduce erosion, reduce runoff, and facilitate continued firebreak protection. Access to the opposite side of the gulch is impeded by the residential properties, making the SW side the logical place to provide machine access to the top of the gulch. The proposed access road is approximately 5,580 feet long by 14 feet wide. NRCS recommends the application of wood chip mulch and seeding between the proposed access road and the top of the gulch bank:

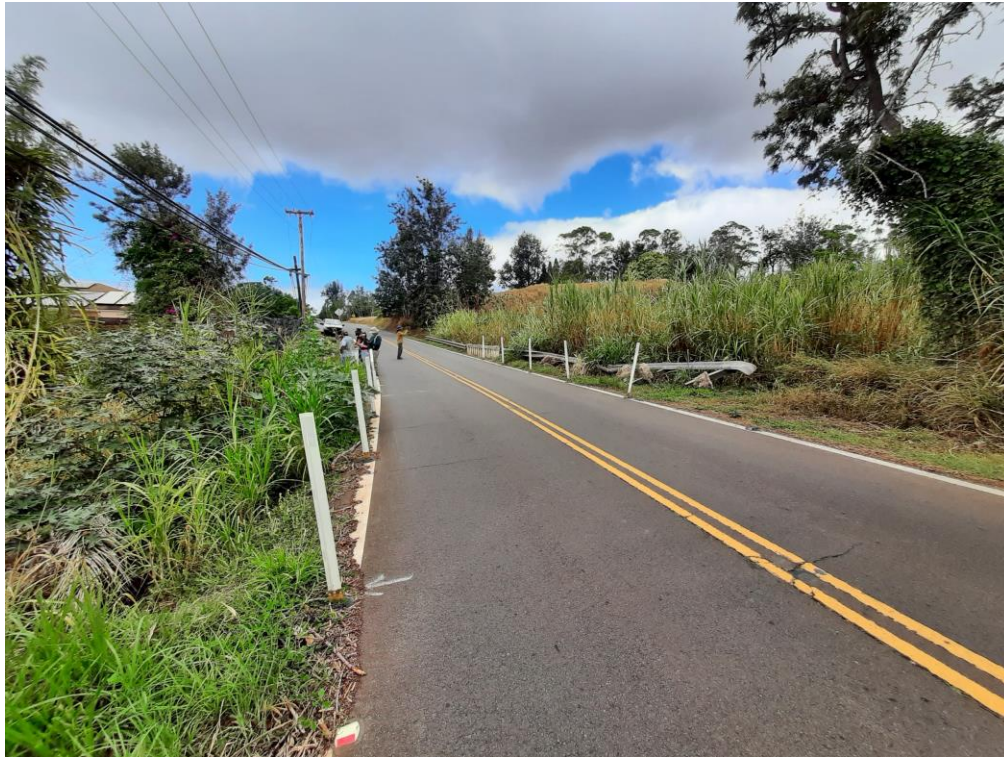
Without intervention, woody debris and sediment is expected to obstruct culverts, bridges and associated roads needed for transportation, including emergency services. For example, the bridge immediately downstream of the Kula burn unit, at Lower Kula road, already has a history of overtopping. Fire induced damage to the watershed will exacerbate this problem.

Overtopping damage visible on the downstream guard rail at Lower Kula road

NRCS recommends the clearing and removal of debris from streambeds within the burn area. Woody debris, dead trees, and trees with burn damage should be removed from stream beds to prevent flow obstructions and scouring. Unexposed roots and rooted herbaceous material should be left intact to help stabilize the soil. Additionally, dead and dying trees on the banks of Pulehu Gulch should be removed, where it can be done safely, to reduce the deposition of woody debris into the waterway and to prevent tree throw erosion. When removing trees on the bank slopes, do not remove the stumps. Stumps should be cut to a height of 2 to 3 feet above the ground level to provide potential anchor points along the slope. Clearing and debris removal work typically commences from the top of the watershed and advances toward the bottom.
