Emergency Watershed Protection Program (EWPP) Maui, Hawaii – Olinda Fire:

Olinda Fire DSR Map

Date: 10/18/2023

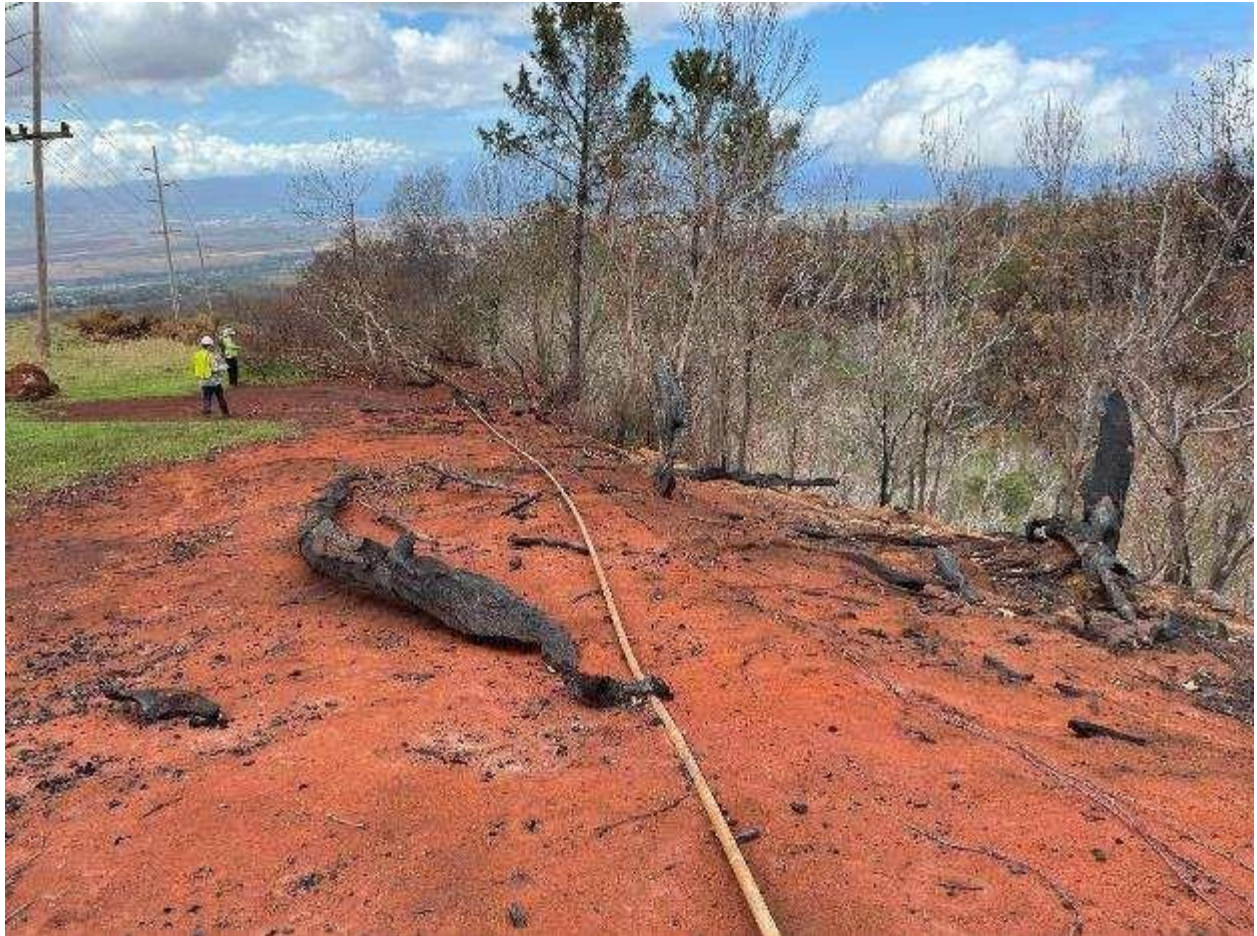
Bare soil between rangeland and Kailua Gulch (proposed mulch area)

Slopes along the gulch are comprised of altered basalt rock and highly erosive mineral soils. The predominant soil type in the area is Pane Silt Loam.

NRCS recommends the application of wood chip mulch (3" thickness) along the outer gulch banks in areas where the soil is bare and sloping into the gulch. Wood chips are locally available from non-native tree species. In the specific case of organic mulches, use of NRCS EWPP funding is only permissible for purchase, production or spreading of organic mulches sourced from the island of Maui.

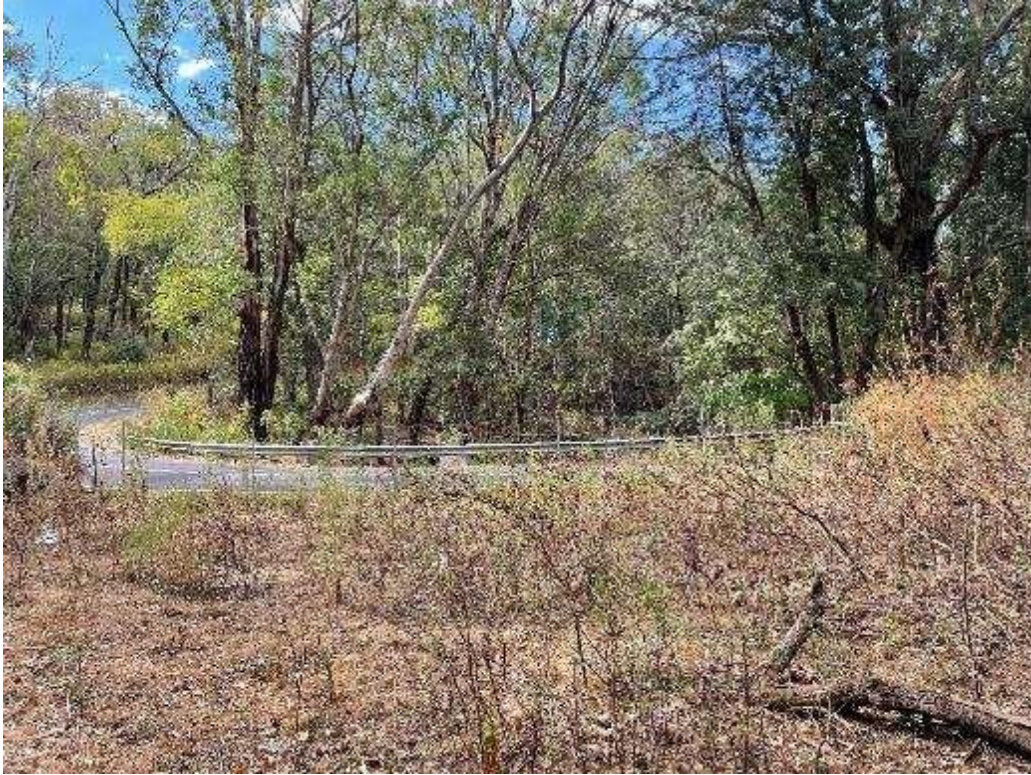
Low-flow crossing at Kealaloa Avenue (Debris basin proposed at this location.)

NRCS recommends the installation of a debris basin located upstream of the Kealaloa Avenue low-flow crossing easement. This basin will allow debris and sediment to settle out before becoming a road hazard and will provide additional warning for drivers and maintenance crews. The proposed basin is approximately 0.5 acres in area and 3 feet deep with 33% slopes around the perimeter. This work includes removing existing vegetation, removing soil, and seeding with grasses of common groundcover species, with proven short-term restoration values that are not weed risks such as annual rye grass (*Lolium multiflorum*) or perennial rye grass (*Lolium perenne*). Other perennial groundcover species that are already naturalized in this landscape could be included in such mixes, however NRCS must approve all species and seeding rates prior to application for EWPP-funded work.

NRCS recommends the installation of Road May Flood warning signs along both approaches to the Kealaloa Ave low-flow crossing and proposed debris basin. This crossing is expected to receive an increase in sediment, woody debris, and water flow as a result of the burn scar.

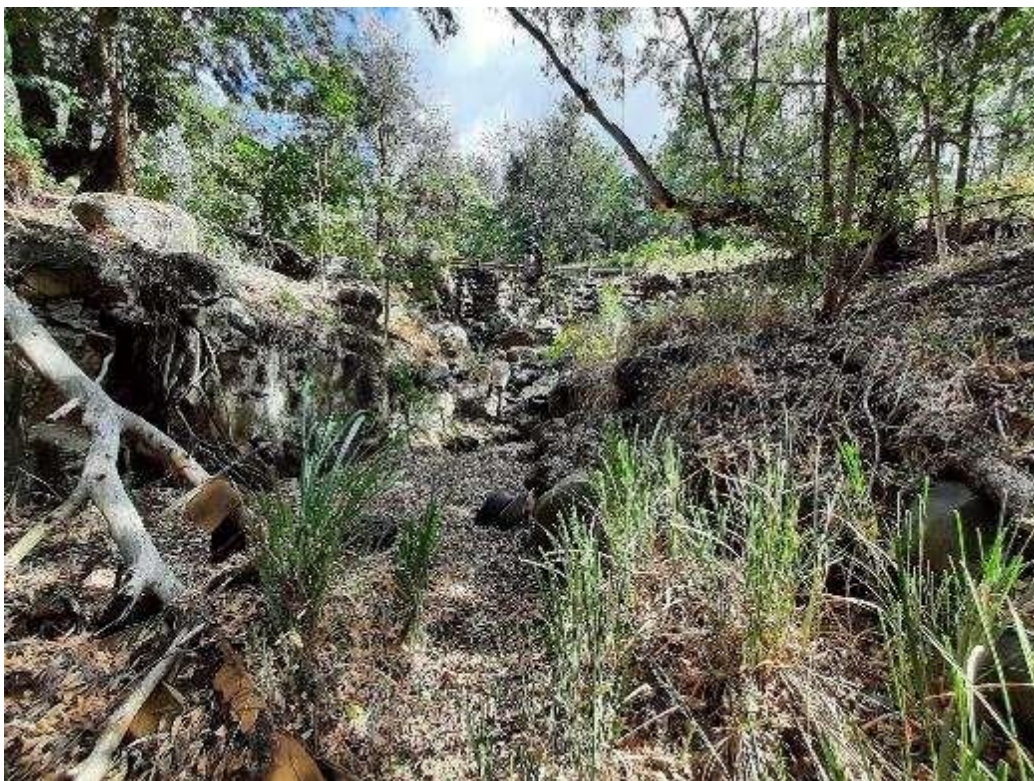
Kealaloa Avenue low flow-crossing (looking upstream toward the crossing)

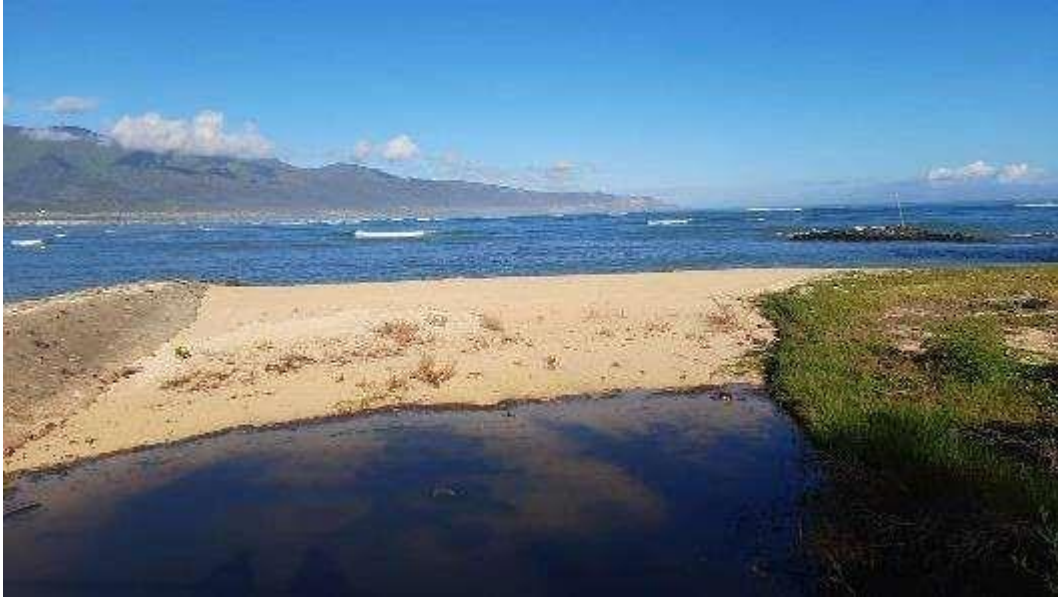
Outlet of the Kaluapulani Gulch Watershed into Kanaha Beach Park, Kahalui Bay

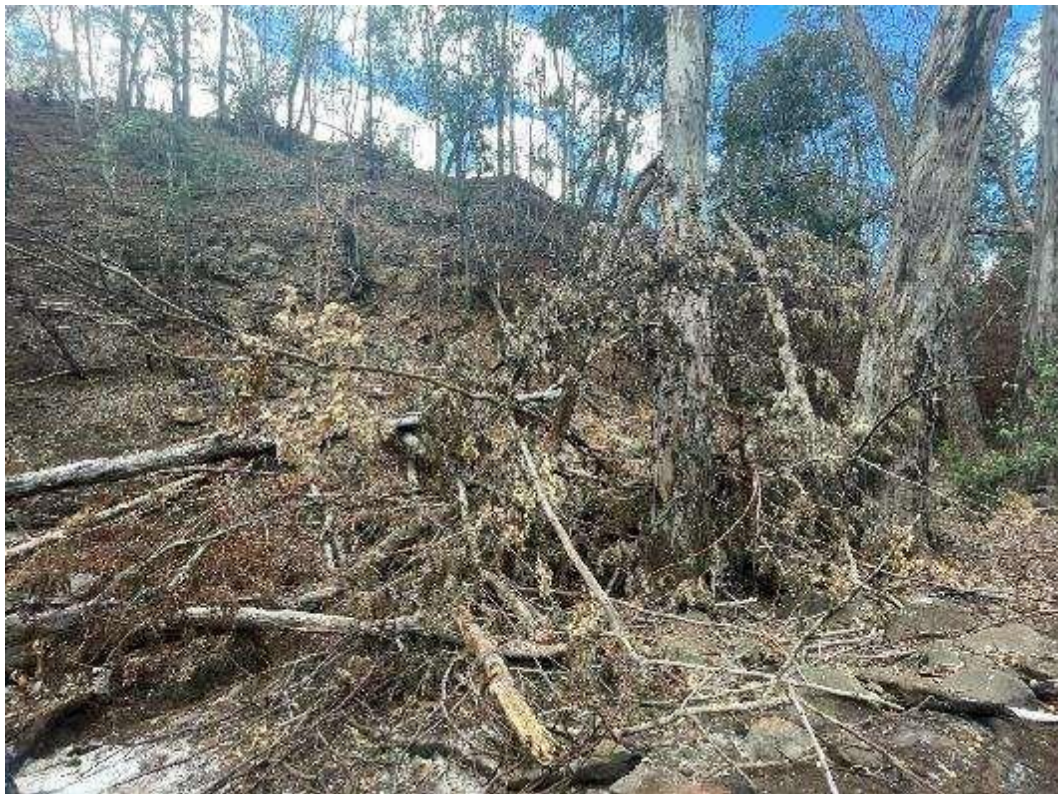
Without intervention, woody debris is expected to obstruct culverts and roadways needed for transportation, including emergency services. Such obstructions have the potential to cause flooding of adjacent lands and communities.

Woody debris in Kaluapulani Gulch (recommend clearing and debris removal)

NRCS recommends the clearing and removal of debris from the streambed within the Kaluapulani Gulch burn area. Woody debris, including dead and dying trees, should be removed from the bed of the stream to prevent mobilization and subsequent plugging of the culvert under Kula Highway. Ideally, the removed material will be chipped and spread along the top of the gulch banks where the burn intensity was high and little organic material remains. Unexposed roots and rooted herbaceous material should be left in tact to help stabilize the soil. Clearing and removal work typically commences from the top of the watershed and advances toward the bottom.

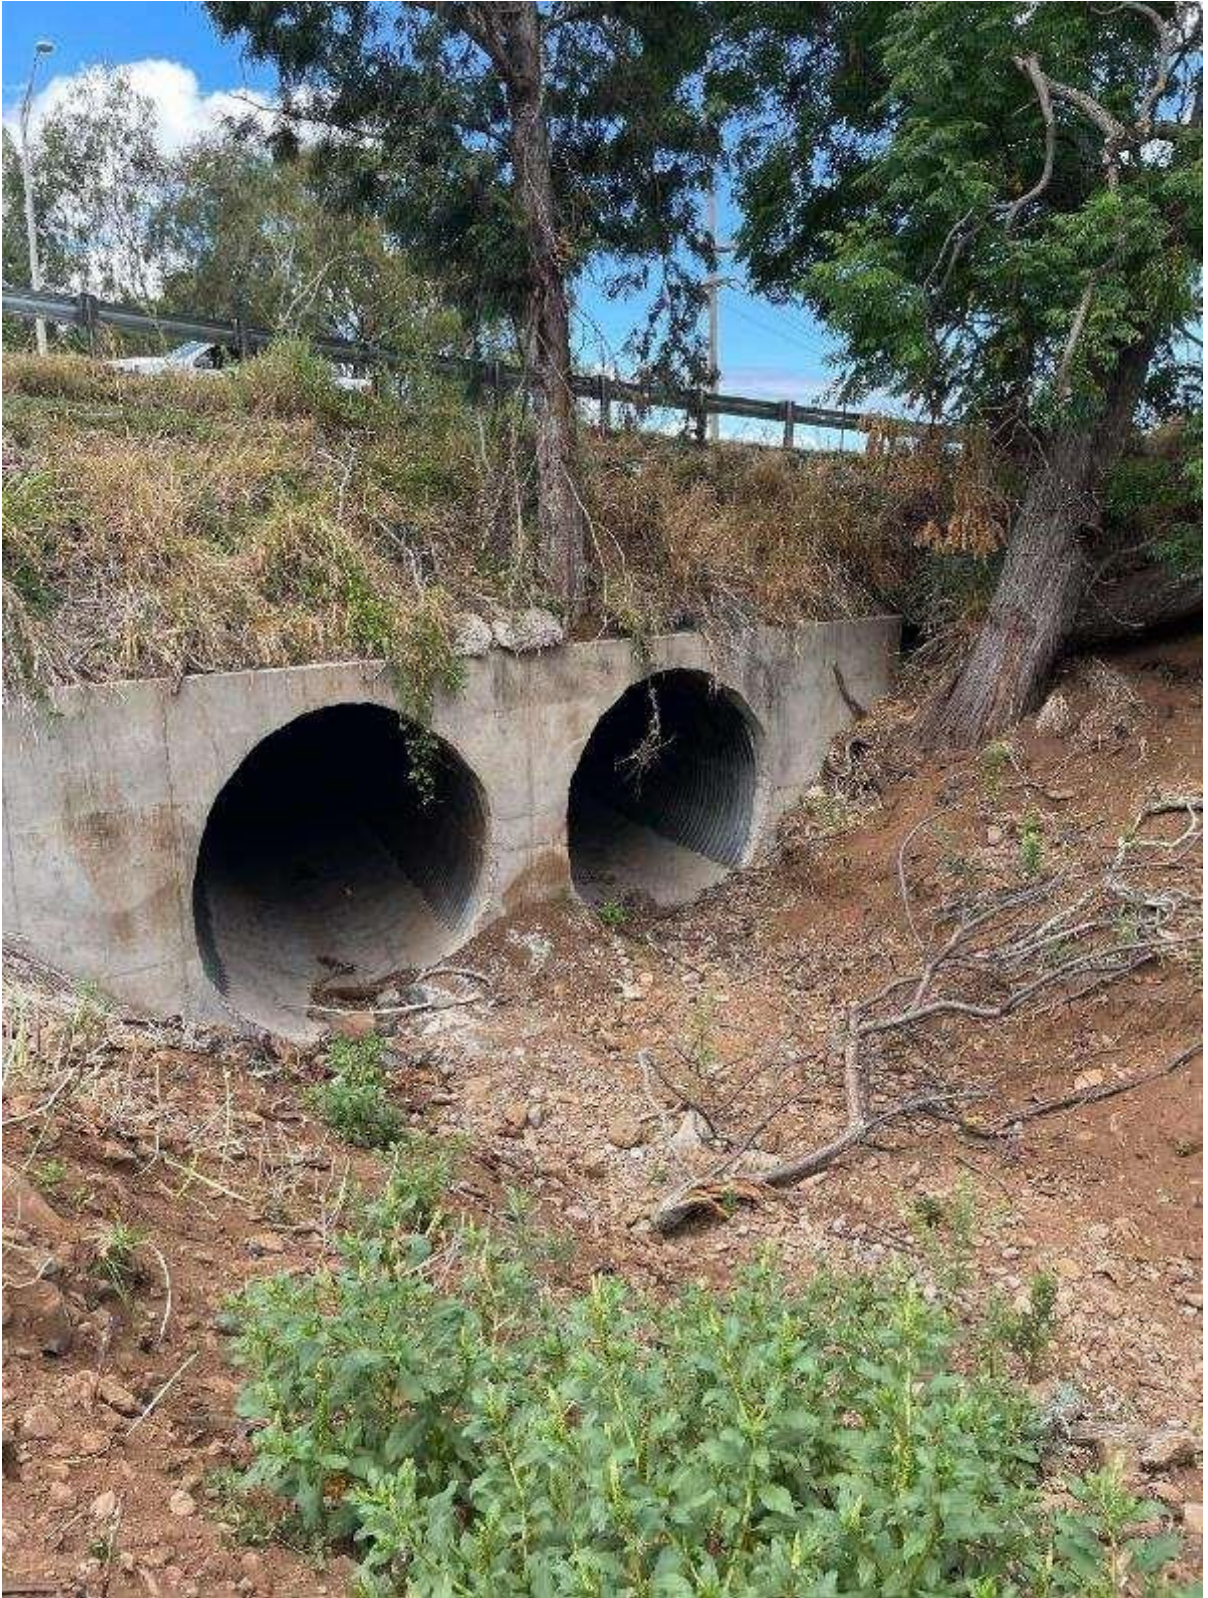
Kula Highway double 10' culvert below Kaluapulani Gulch burn area (recommended upstream clearing and debris removal)

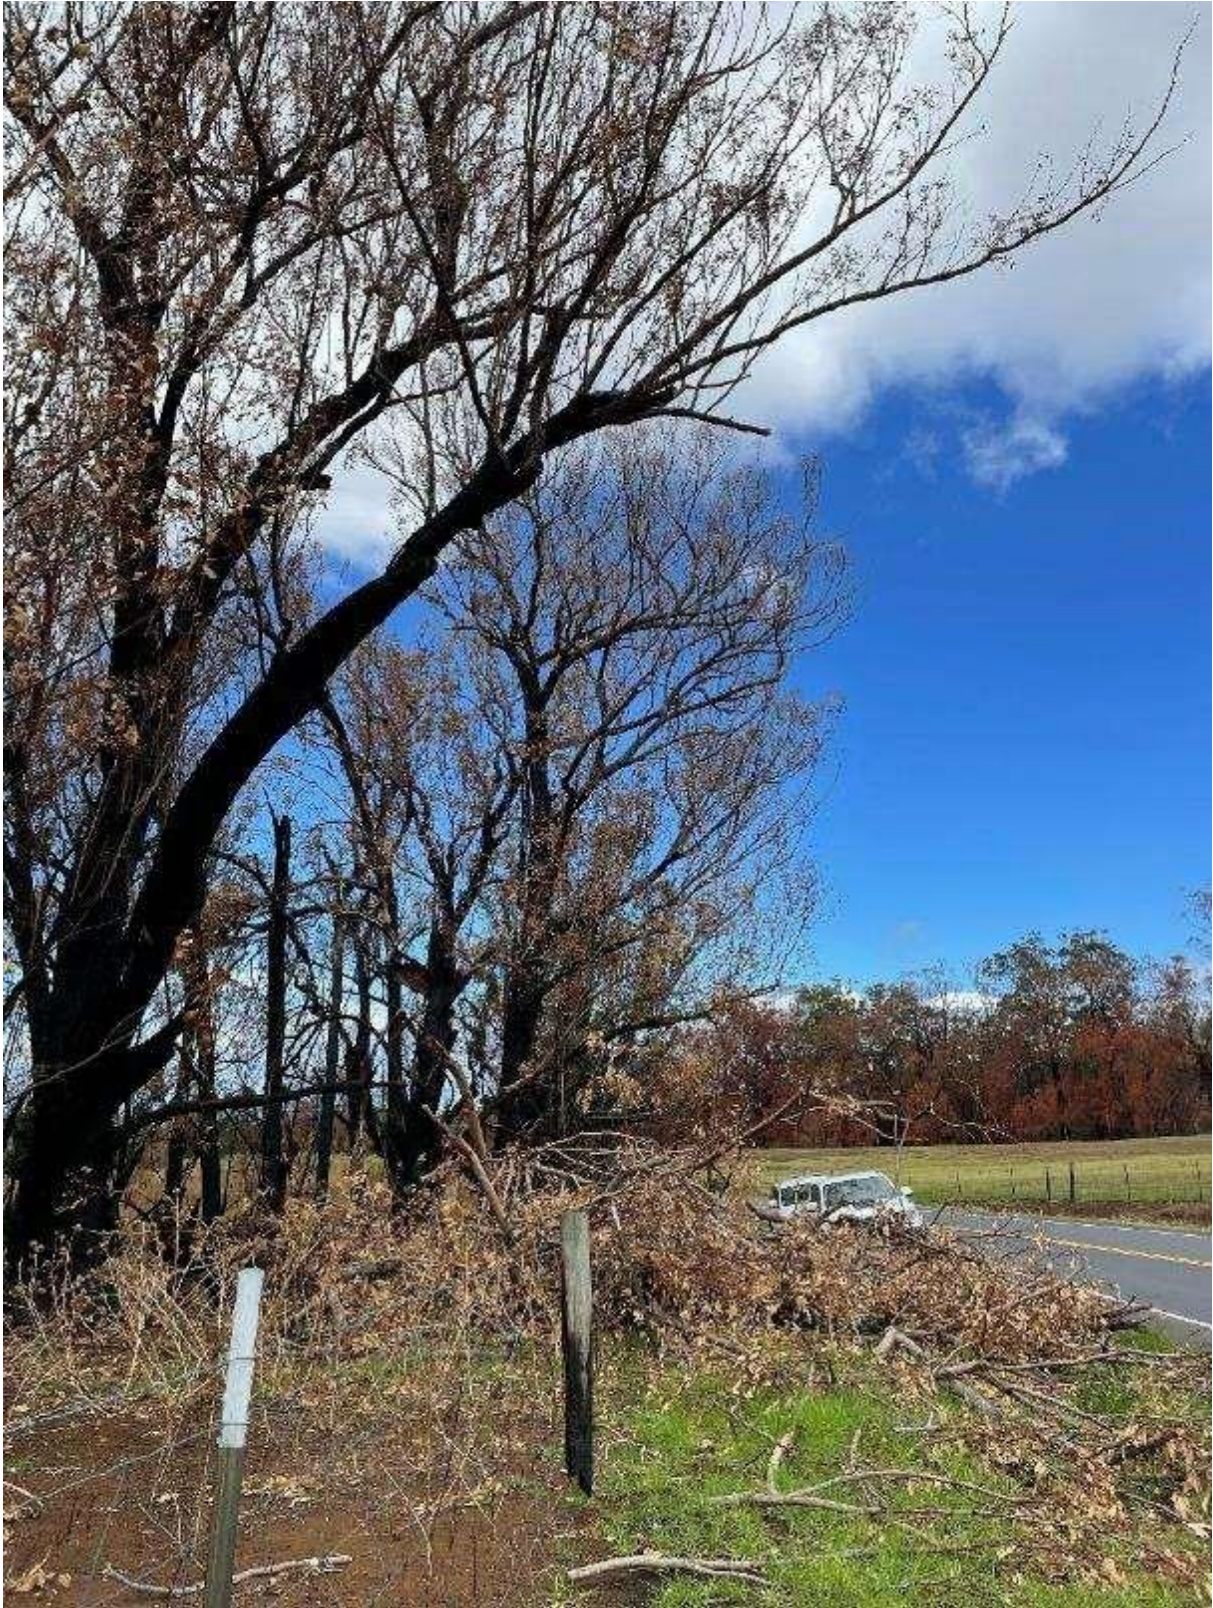
Hazard trees along Haleakala Highway and debris recently removed from highway

NRCS recognizes the need for removal of hazard trees within striking distance of the roadways and powerlines within the Olinda burn unit. However, EWPP funds are intended to address impairments to the watershed. For this reason, the removal of hazard trees is not proposed in this report nor indicated on the attached Olinda Fire DSR Map. NRCS is working with other partners to seek support for this need.
