## Emergency Watershed Protection Maui, Hawaii – Pulehu Fire:

### OVERVIEW

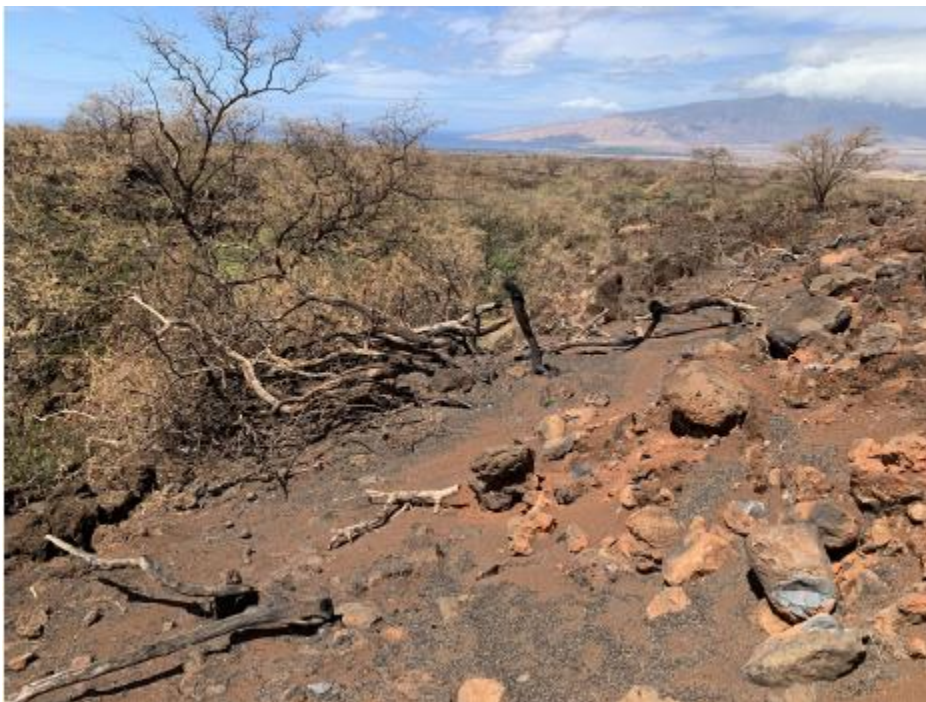
There are a few areas where the gulches were burned and trees and debris now present should be removed. Typically, the fire burned the base of the tree and continued burning up the tree to about 2-4 feet above the base, causing many trees to fall over. The tops of the trees did not burn, indicating that tree didn't fall until after the fire had passed. NRCS recommends burned trees that have fallen into the gulches be removed and has identified the areas where tree removal will be needed. This includes 3,000 feet along the gulches as shown in the image below. The trees could be chipped/mulched and spread along the top banks of the gulch. These are the locations where the fires burned hot and the mulch may assist in reestablishing vegetation and stabilizing exposed soils. NRCS recommends that a forester evaluate any standing trees that need to be removed. Again, in the specific case of organic mulches, use of NRCS EWPP funding is only permissible for purchase, production or spreading of organic mulches sourced from the island of Maui.

*Example of tree debris at head of gulch*

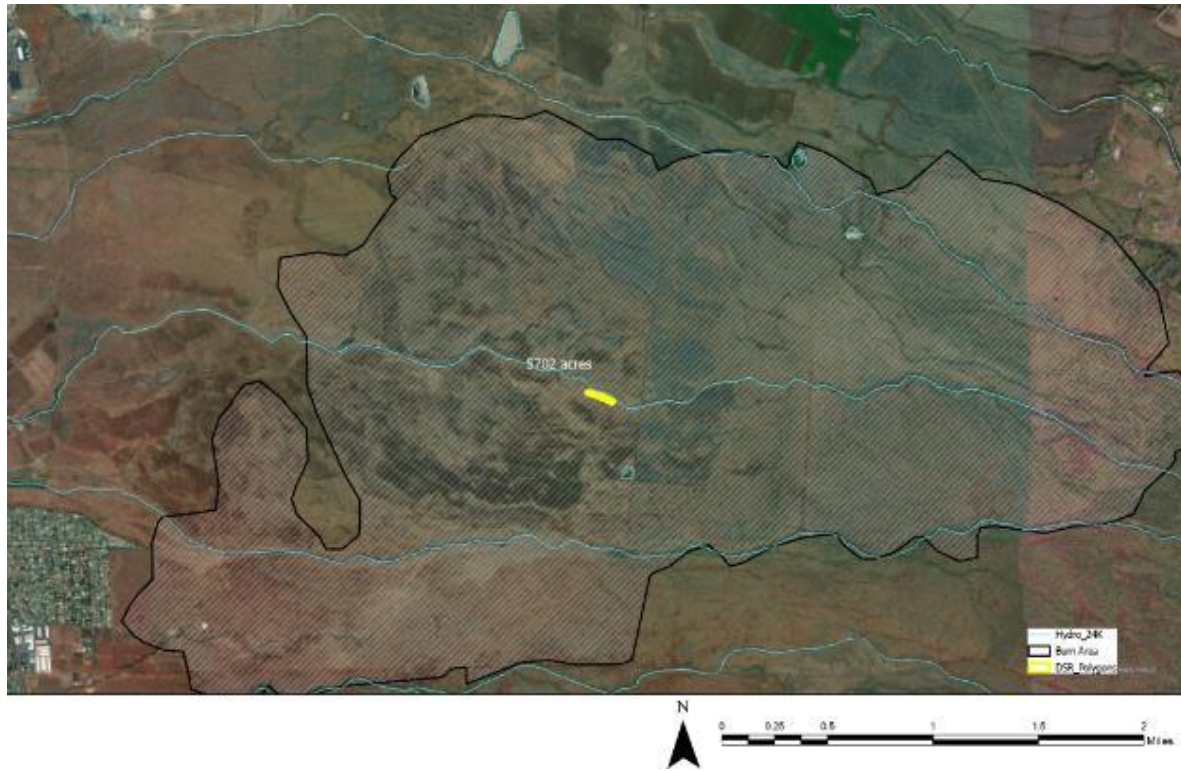
During a site visit, a network of previously established earth berms were observed at the top banks of principal natural drainages i.e. gulches. These were probably created as rocks and soil for land smoothing were removed from cultivated fields. In some locations, small sections of the earth embankments have been removed. NRCS recommends that in these locations totaling approximately 650 linear feet that the berms be restored to control storm surface water flow into gulches.

*Earth berm location at the top bank of the gulch.*

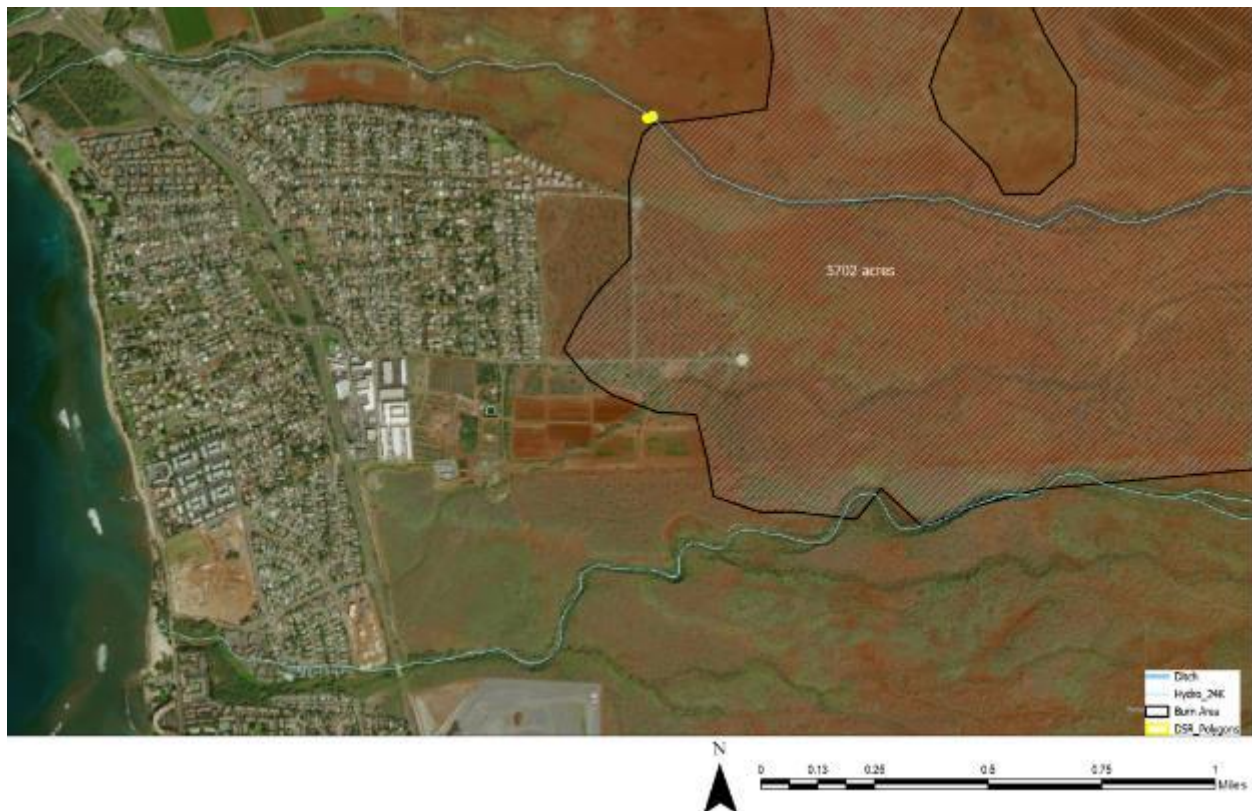
During the fire, several dozers were used to cut firebreaks. In the process of establishing the firebreaks, the dozers crossed Keahaiwi Gulch and pushed earthfill into the channel. NRCS recommends that this earthfill be removed from the channel and the channel restored to match the existing channel cross section.

*Remove earthfill in the channel caused during active fire response efforts to establish a firebreak.*

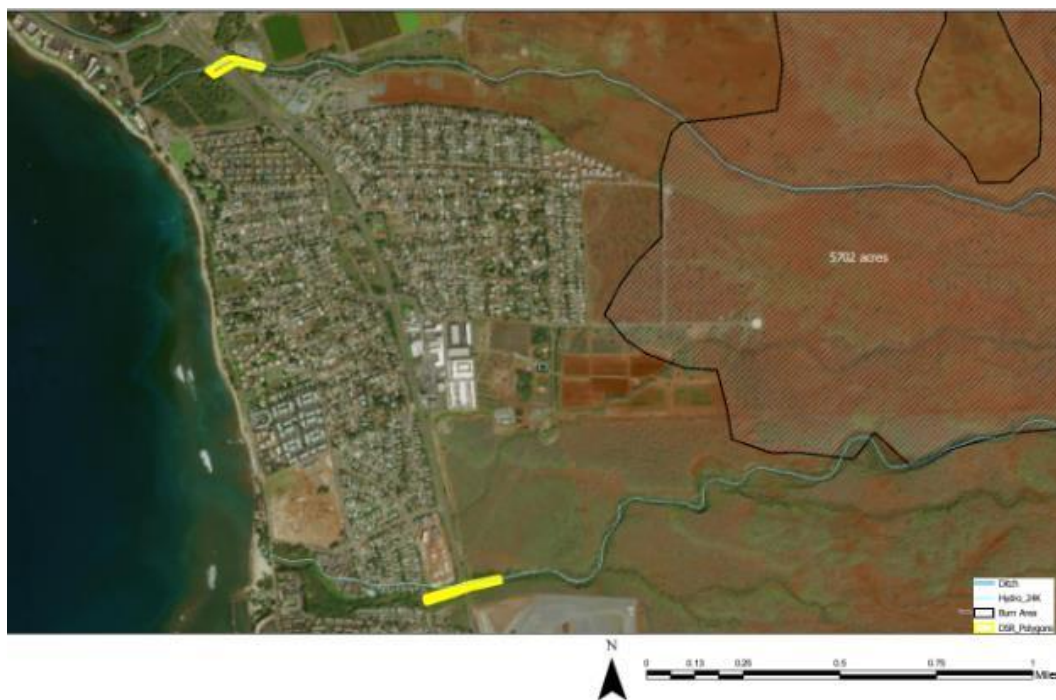
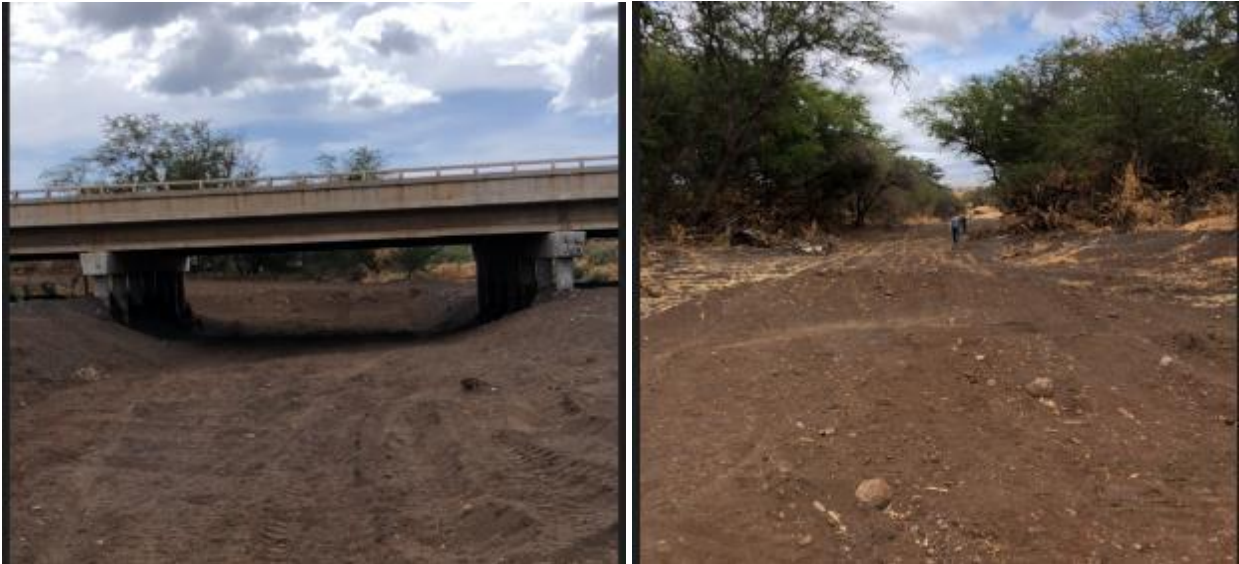
In other areas, storm events prior to the Pulehu Fire incident resulted in sediment laden runoff that deposited significant quantities of sediment in gulches and urban drainage channels, and also led to water and sediment inundation in developed areas of Kihei. As drainage channels pass through lower elevations and approach the ocean, water runoff velocity will slow and sediment will be deposited. This is particularly noticeable where primary road bridges cross drainages near Kihei, and where the channels are considerably wider both upstream and downstream of the bridges. NRCS recommends that existing sediment at the bridge locations identified below be removed. This work will restore hydraulic function and capacity of the drainages and help buffer sediment delivery risk from eroded landscapes to ocean and near-shore reef systems during future storm events. Additionally, both South Kihei Rd and Piilani Highway are at risk of flooding due to inadequate gulch capacity to convey stormwater. This becomes especially problematic at the confluence of N. Kihei Rd, S. Kihei Rd, and Piilani Highway just Northwest of the Waiakoa Gulch, as this is the only access into and out of the Kihei and Wailea communities.

*Sediment removal under bridge at Piilani Hwy./Waiakoa Gulch and sediment at Kulanihakoi Gulch)*

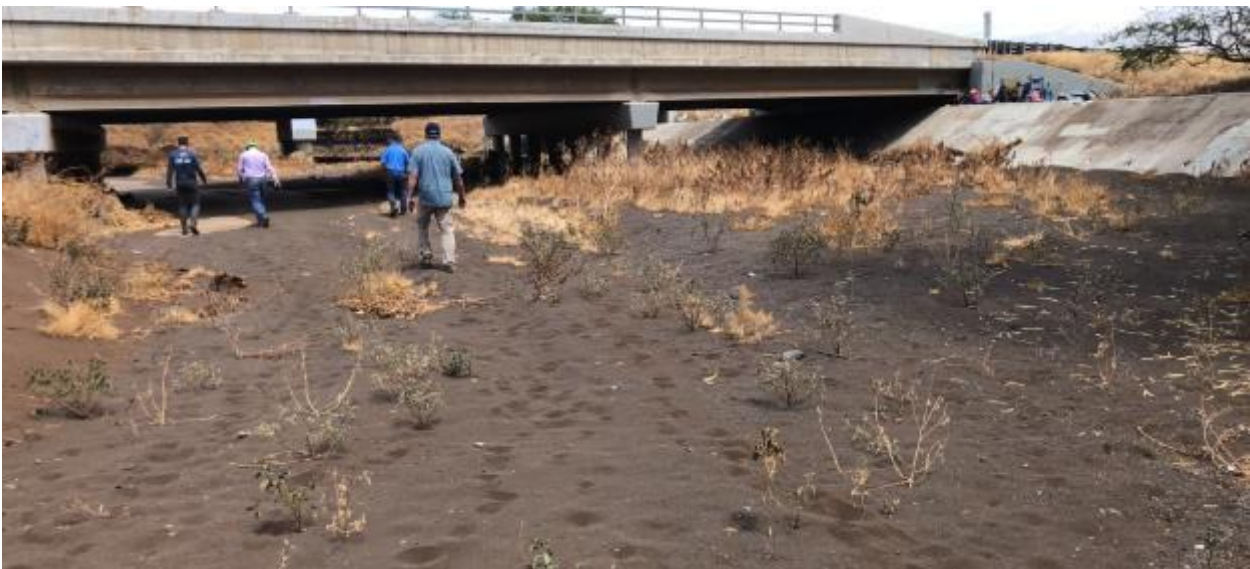
*Proposed sediment removal underneath the bridge at Piilani Highway and Kulanihakoi Gulch. Note that sedimentation accumulation in primary drainages near Kihei town have attained depths up to 17 feet over many years, but in some places at least four feet in just the last two years prior to August, 2023. This extreme loss of fertile surface soils in adjacent watershed areas such as the Pulehu burn unit underscore the importance of post-burn vegetation restoration and soil stabilization needs.*
