## Emergency Watershed Protection Maui, Hawaii – Pulehu Fire:

### OVERVIEW

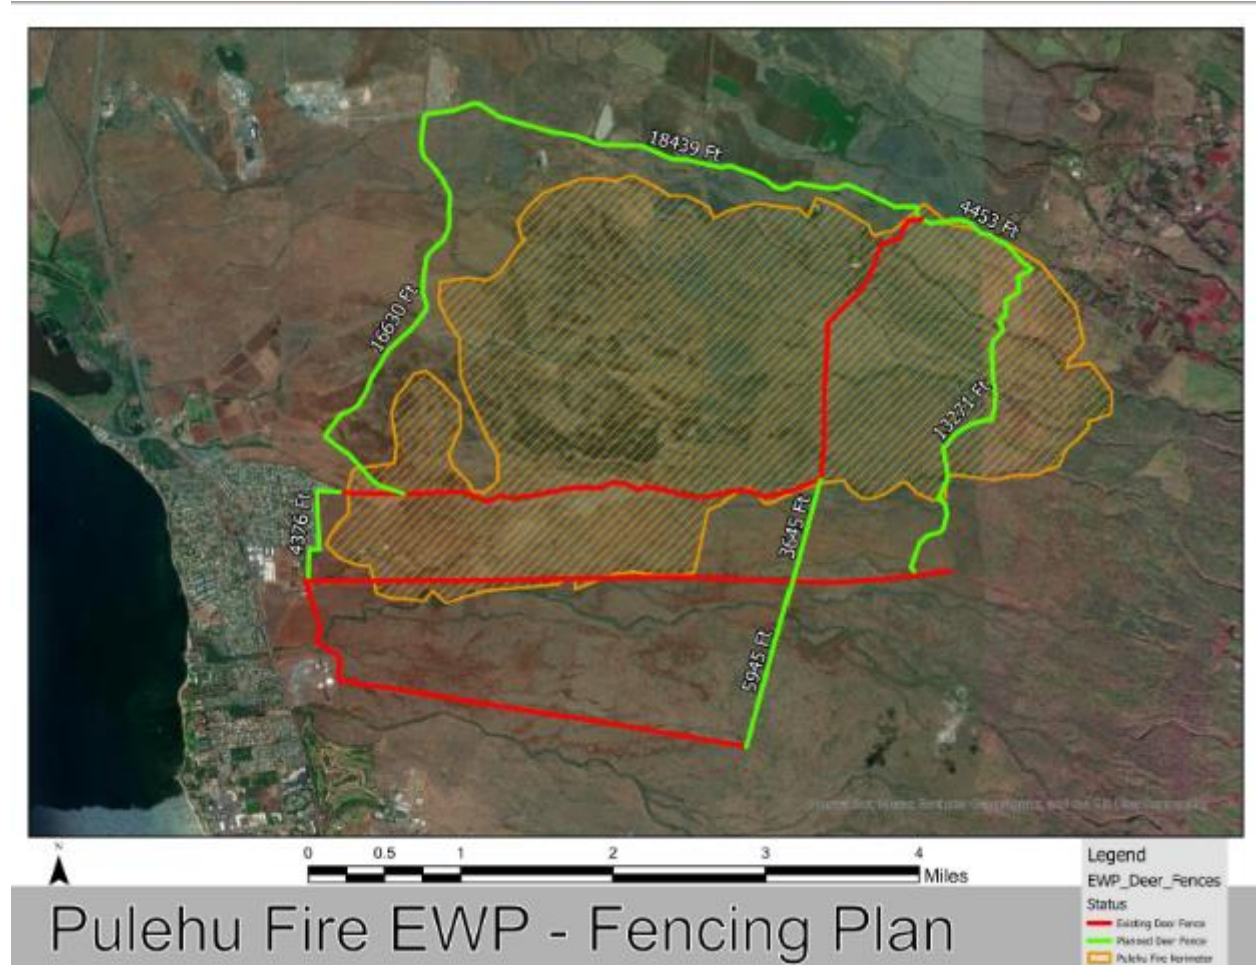
*Proposed NRCS deer fences are shown in green. Existing deer fences are shown in red.*

Fencing the burned area is the highest priority and critical to create a favorable environment for the existing grasses to resprout and recover and for newly broadcast seed to germinate and establish without being subject to intense grazing pressure from axis deer. Fences must be woven wire with one barbed wire strand placed along the bottom and be at least 6 feet tall. The fencing alignment will be coordinated with the existing landowners and their business operations. The estimated length of fencing need is approximately 14 miles. Proposed fences (shown in green) are laid out along the most advantageous routes to tie into existing deer fences (shown in red) and create manageable units.

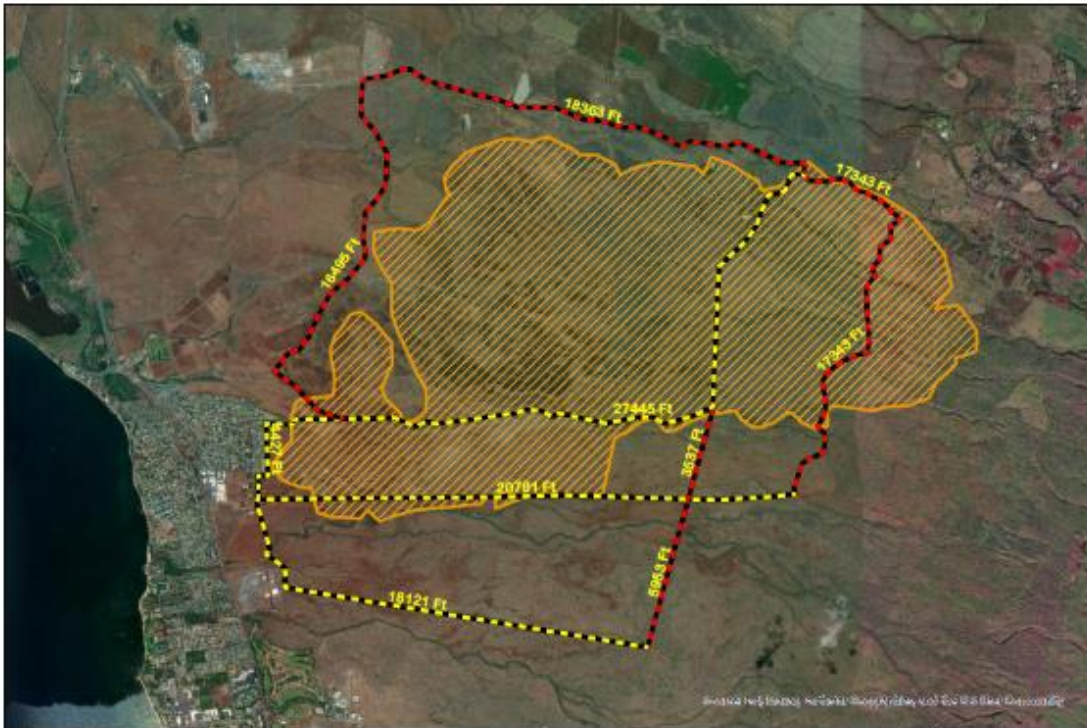
## Pulehu Fire EWP - Firebreaks

*Moderate installation firebreaks are represented by yellow/black lines. Difficult installation firebreaks are represented by red/black lines.*

The preferred strategy is to install a network of interconnected firebreaks. The “network” approach consists of installing a series of multiple, parallel and perpendicular firebreaks, which creates the effect of compartmentalizing and containing fires when they start, preventing them from growing to an unmanageable size. The network of firebreaks also provides responders with direct access to potential fires, reducing response time and improving vehicle and resource access. The intent is to facilitate fire suppression efforts such that future fires would be fought at a manageable scale with local resources.

Firebreak dimensions were designed to handle the expected flame lengths and fire behavior based on the fuel sampling and estimation study results. Maximum fuel heights were measured at 30 inches (2.5 feet), which corresponds to a *minimum* firebreak width of 25 feet. Since this requires multiple passes with a bulldozer, both “moderate” (47% of total length) and “difficult” (53% of total length) installation cost rates were employed based on terrain. A 10% correction factor was added to the total length of the firebreaks to account for slope and difficult terrain. The total length of all planned firebreaks was estimated at 145,730 feet. The proposed alignments for these firebreaks that are depicted in the figure below are idealized to a degree. NRCS recognizes each landowner will dictate whether these recommendations will be followed in full, in part or at all. However, the objective is to encourage cooperation across ownerships to support a firebreak network that protects the entire landscape.

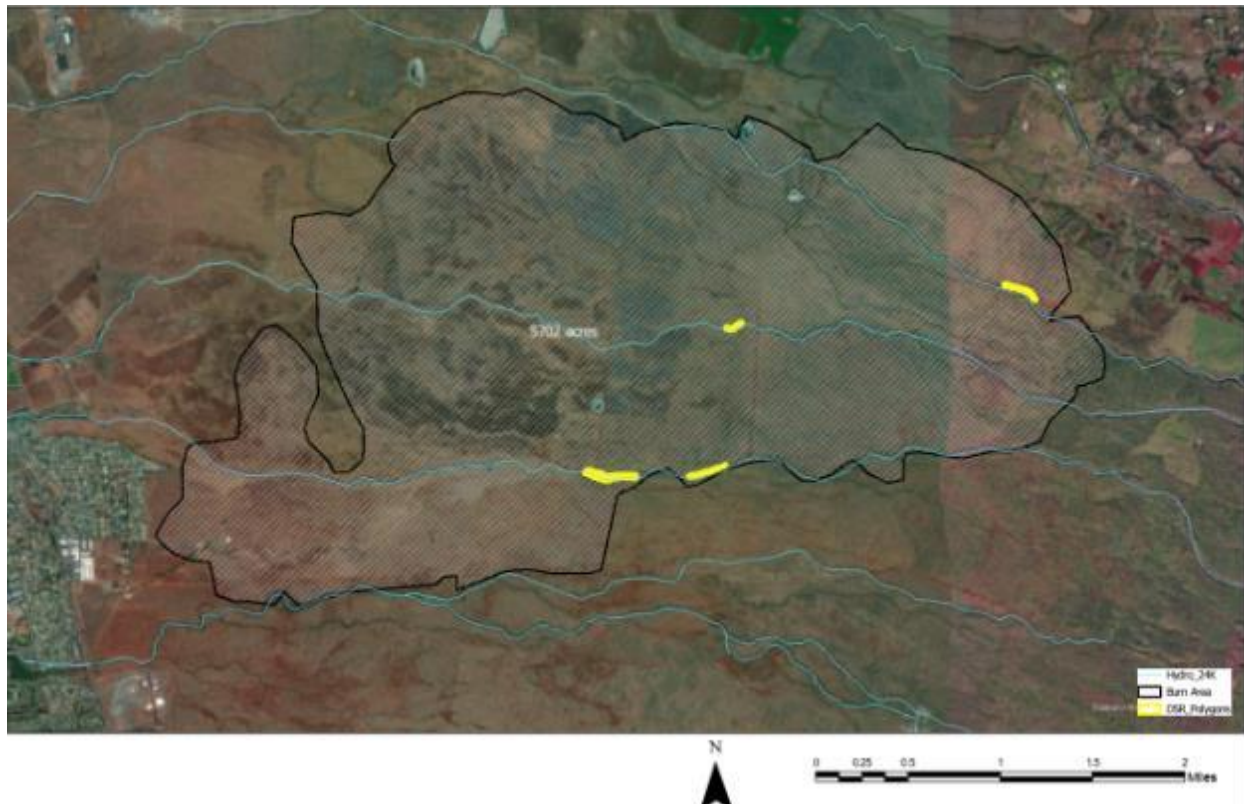
There are a few areas where the gulches were burned and trees and debris now present should be removed. Typically, the fire burned the base of the tree and continued burning up the tree to about 2-4 feet above the base, causing many trees to fall over. The tops of the trees did not burn, indicating that tree didn't fall until after the fire had passed. NRCS recommends burned trees that have fallen into the gulches be removed and has identified the areas where tree removal will be needed. This includes 3,000 feet along the gulches as shown in the image below. The trees could be chipped/mulched and spread along the top banks of the gulch. These are the locations where the fires burned hot and the mulch may assist in reestablishing vegetation and stabilizing exposed soils. NRCS recommends that a forester evaluate any standing trees that need to be removed. Again, in the specific case of organic mulches, use of NRCS EWPP funding is only permissible for purchase, production or spreading of organic mulches sourced from the island of Maui.

*Tree Removal and Mulching Locations*

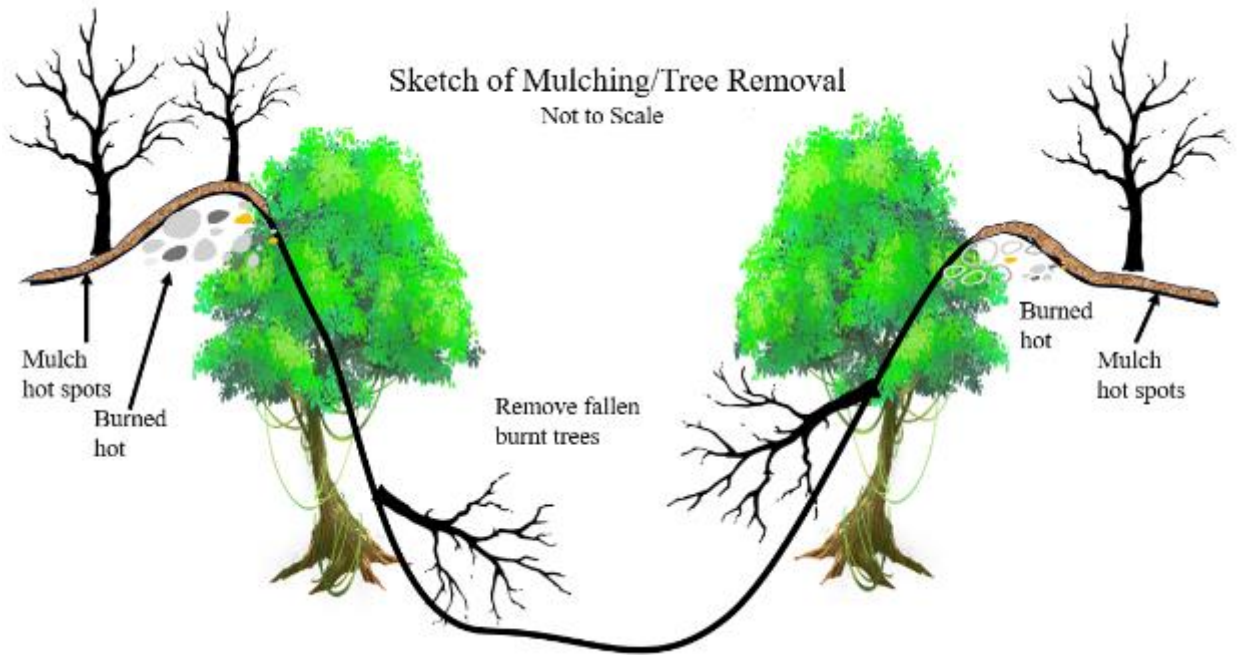
*Sketch of Tree Removal and Mulching*

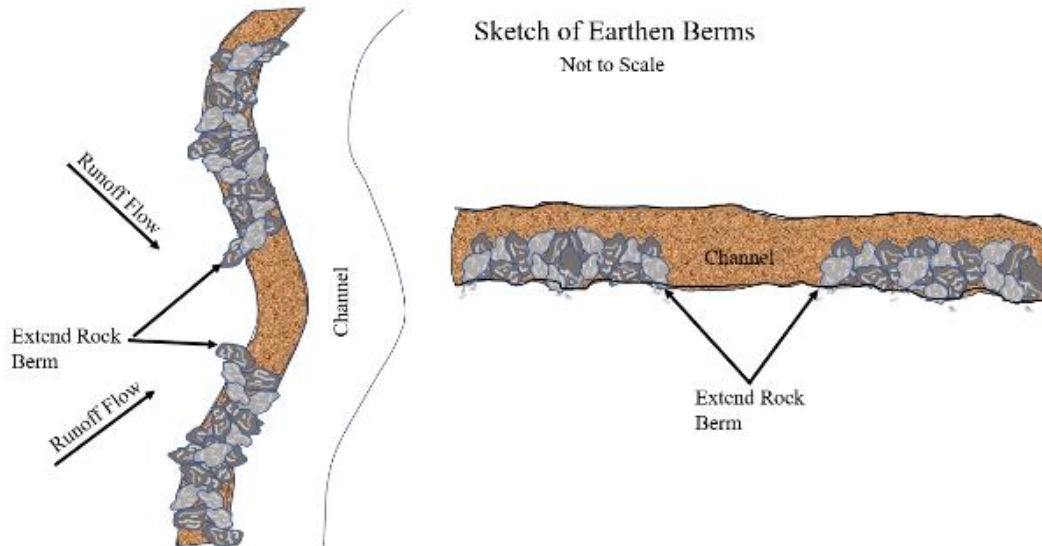
During a site visit, a network of previously established earth berms were observed at the top banks of principal natural drainages i.e. gulches. These were probably created as rocks and soil for land smoothing were removed from cultivated fields. In some locations, small sections of the earth embankments have been removed. NRCS recommends that in these locations totaling approximately 650 linear feet that the berms be restored to control storm surface water flow into gulches.

Sketch showing construction of earth berm along the top bank of the gulches  
**NATURAL DRAINAGES (GULCHES) – ROCK BARRIERS**

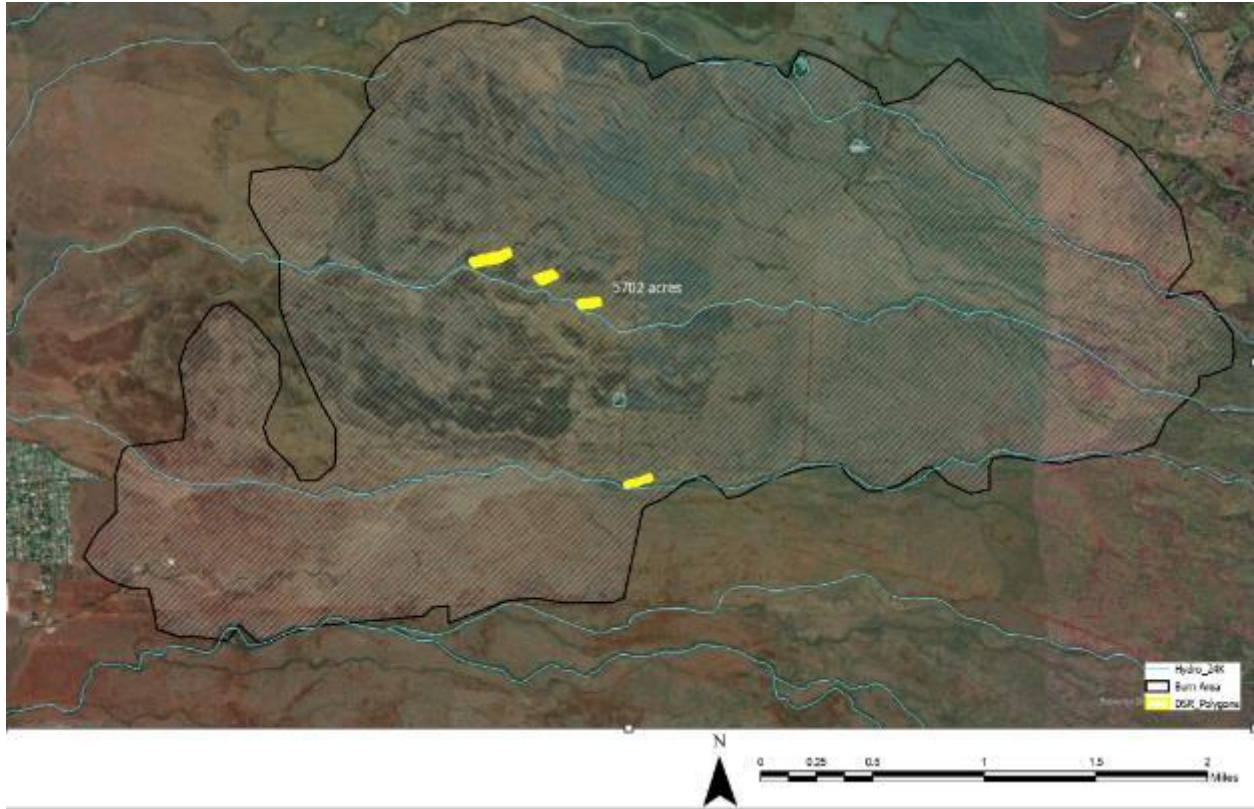
There are several tributaries identified that NRCS recommends placing temporary rock barriers at the bottom channel to catch sediment and debris. The concept here is to provide short-term sediment trapping infrastructure to capture a portion of storm water sediments that are likely to be associated with initial post-fire rainstorm events. As revegetation efforts progress and surface soils within the burn unit are better protected, these barriers along with trapped sediments can be removed as an option. Additionally, the landowners can periodically remove sediment and debris from behind the check dams to extend their lifespan and functionality if desired. Rock barriers should be constructed with 2-3-foot diameter rocks and placed no higher than 2-4 feet above the channel bottom. There following 4 tributaries identified, with a total of 25 rock barriers suggested.

*Rock Sediment Detainment Structures on Tributaries*

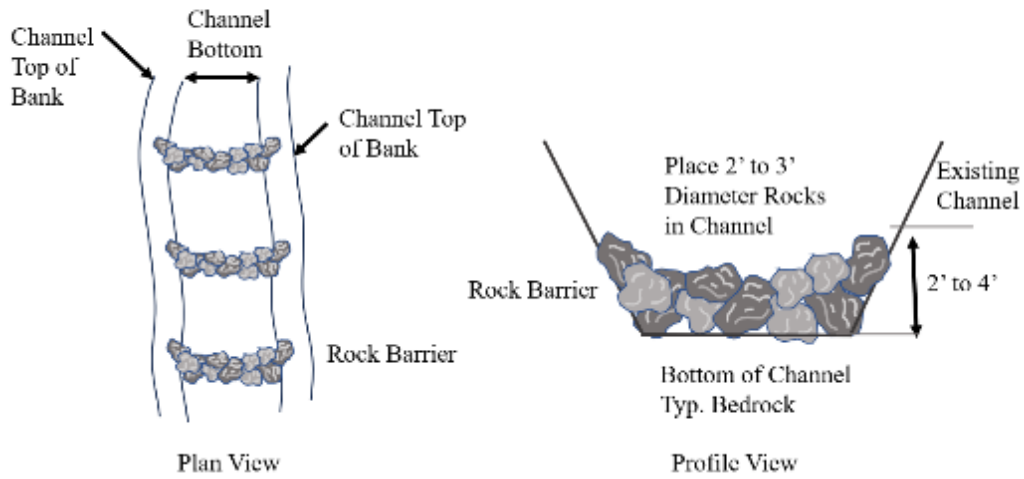
### Sketch of Rock Channel Structure

*Sketch of Rock Channel Structure*
